Manhole Inspection Summary

Manhole # S07YY1008MH

Location Address: **5811 Rockwood Ave** Cross Street: **Woodcrest Ave**

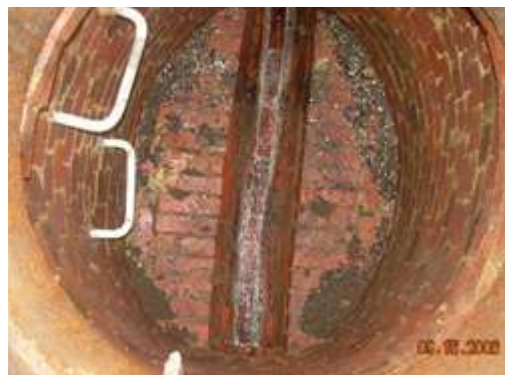
Top View

Bench debris

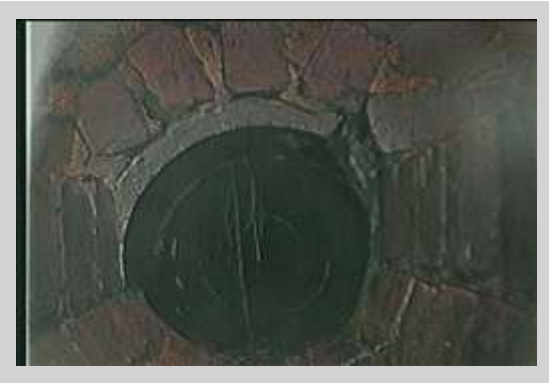
10 in. Circular Gravity Sewer Pipe Out @ 12 O'Clock

Comments **O12 pipe has roots in pipe.**

Pipe Material: **Clay** ☐ Pipe Lined

Invert Depth: **6.05** (ft.) Flow Characteristics: **Fast**

Infiltration: **None** Pipe Seal Cond: **Unknown**

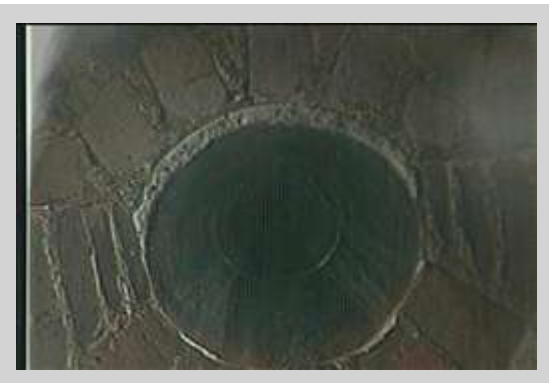
10 in. Circular Gravity Sewer Pipe In @ 6 O'Clock

Pipe Material: **Clay** ☐ Pipe Lined

Invert Depth: **5.65** (ft.) Flow Characteristics: **Fast**

Infiltration: **None** Pipe Seal Cond: **Sound**
